**TRANSPORTATION SCIENCES CENTER
ACCIDENT RESEARCH GROUP**

**CALSPAN ON-SITE AIR BAG DEPLOYMENT INVESTIGATION
CALSPAN CASE NO. 95-21
VEHICLE: 1995 DODGE CARAVAN
LOCATION: MARYLAND
CRASH DATE: [REDACTED] 1995**

This on-site investigation focused on a child fatality that resulted from the deployment of the passenger side air bag in a 1995 Dodge Caravan. The 7 year old female child occupant was the right front passenger in the Caravan that was occupied by the 43 year old male driver and two additional child occupants seated in the second seat of the seven passenger vehicle configuration. On an approach to a four-leg intersection, the driver was momentarily distracted and failed to detect a red signal phase. He braked, however, the full frontal area of the Caravan impacted the left side area of a 1992 Chevrolet Lumina APV which resulted in deployment of the Dodge's supplemental driver and passenger side air bags. The right front child occupant was out of position in a forward direction as a result of the pre-crash braking force and within a close proximity to the passenger side air bag module assembly. The deploying air bag contacted the underside of her chin, face, anterior neck, an

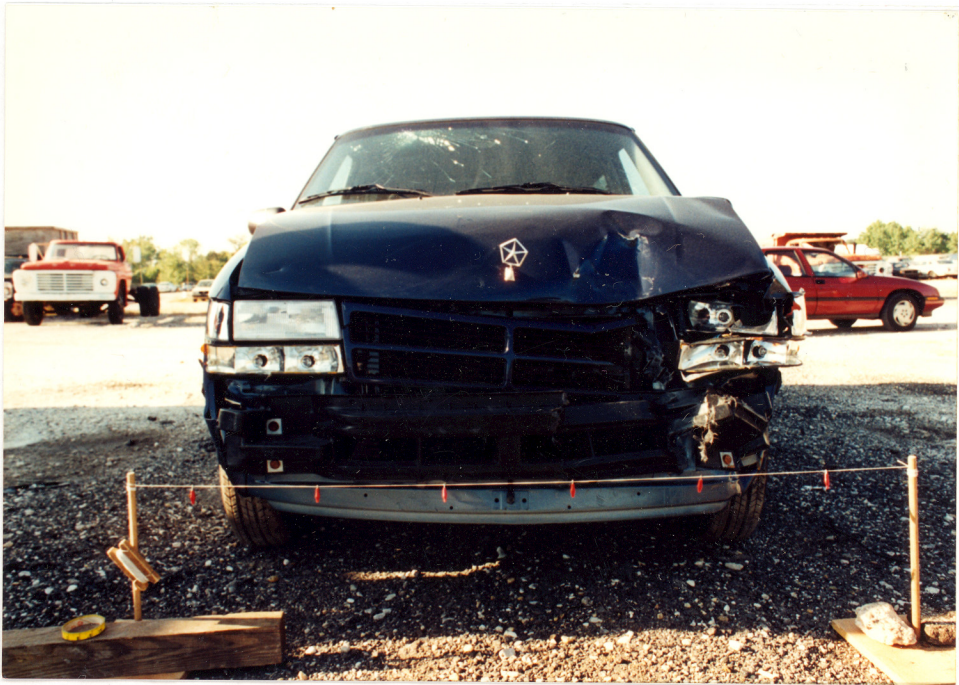
<u>Air Bag Vehicle</u>	<u>Vehicle #2</u>
The 1995 Dodge Caravan sustained moderate damage that was distributed across the entire frontal plane of the vehicle. The front-to-side impact sequence crushed the front bumper structure of the Caravan and separated the bumper fascia from the reinforcement bar. Direct contact damage, which consisted of abrasions, began at the right front corner of the bumper fascia, 77.5 cm (30.5") right of center, and extended 154.31 cm (60.75") to the left corner area. The vertical height of the direct contact damage extended onto the hood face and leading edges of the front fenders.	The 1992 Chevrolet Lumina APV sustained moderate left side damage from its impact sequence with the Dodge Caravan. The composite exterior body panels of the Lumina APV compressed as a result of the impact and rebounded to approximately the original positions. The steel substructure of the left B-pillar and sill areas retained the crush pattern from the engagement. Direct contact damage consisted of abrasions and paint transfers which began 116.2 cm (45.75") forward of the left rear axle position and extended 160.0 cm (63.0") forward to the left front wheel.

11. Frontal damage to the 1995 Dodge Caravan.

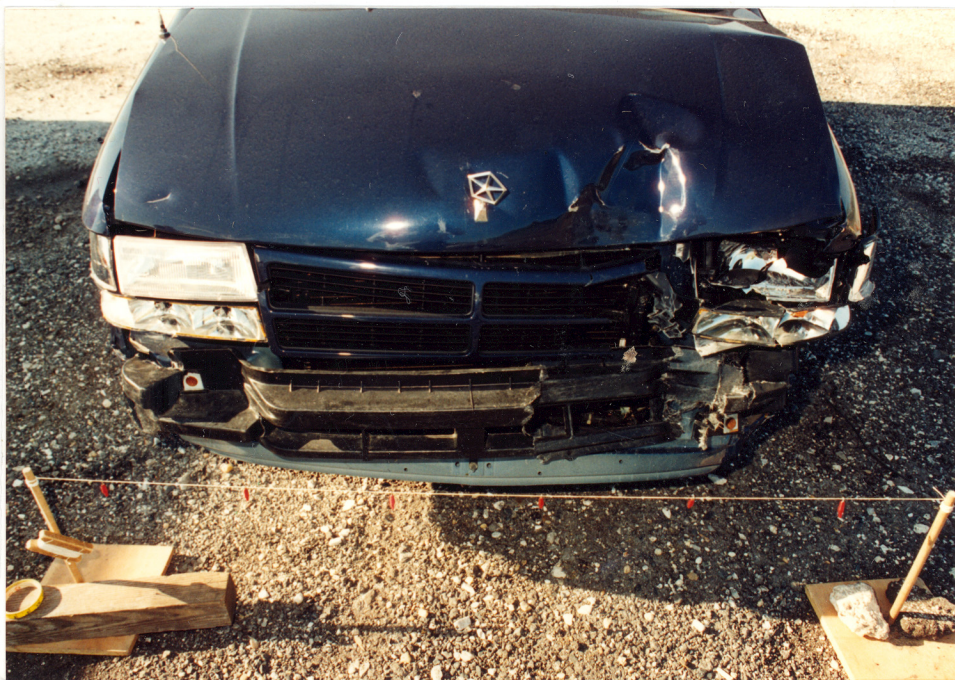
12. Close-up view of the frontal impact damage.

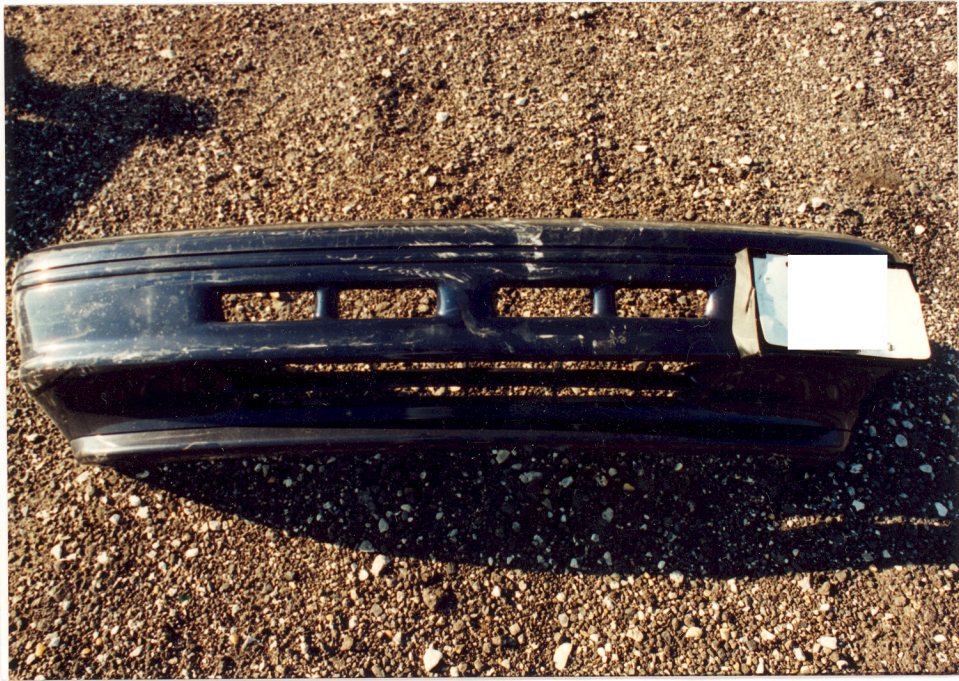
13. Direct contact damage across the full width of the bumper facia (separated).

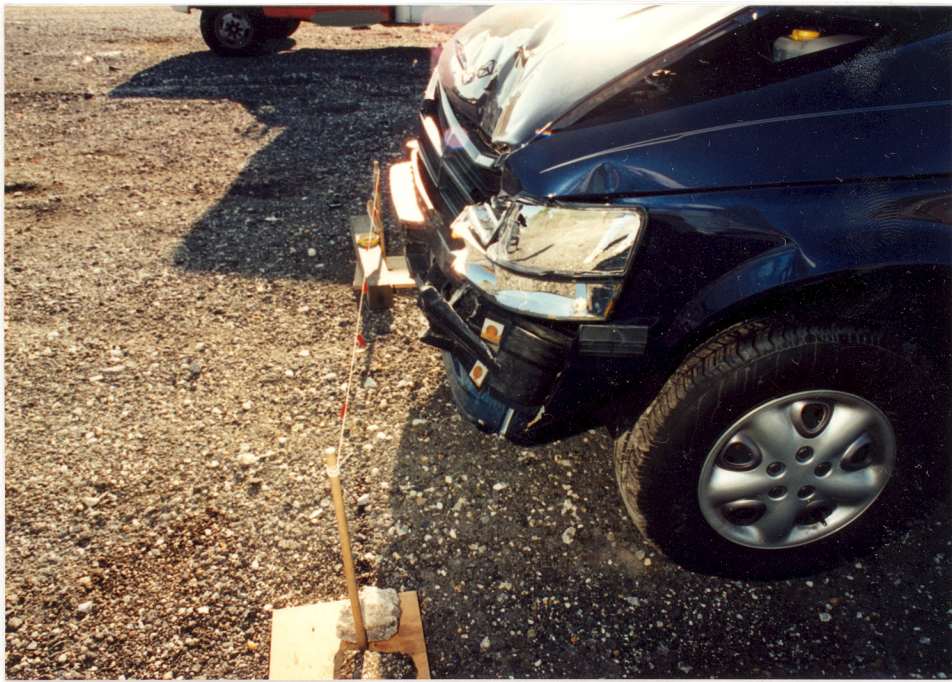
<u>Air Bag Vehicle</u>	<u>Vehicle #2</u>
Exterior (Cont'd.)	<p>Maximum crush was 26.4 cm (10.4") located at the left front corner of the fiberglass-type bumper reinforcement bar. Crush values at bumper reinforcement bar level were as follows: C₁=26.4 cm (10.4"), C₂=23.1 cm (9.1"), C₃=8.9 cm (3.5"), C₄=6.6 cm (2.6"), C₅=4.8 cm (1.9"), C₆=5.7 cm (2.25").</p> <p>Components damaged by the crash involved the front bumper facia and reinforcement bar, grille, left headlamp assembly, both parking light and turn signal assemblies, hood, and both front fenders. Rearward displacement of the frontal structure did not result in reduction of the wheelbases.</p>	<p>Maximum crush was 7.6 cm (3.0") located at the base of the left B-pillar. The residual crush profile was located at the sill of the vehicle and extended from the left A-pillar to the B-pillar. Crush values at this level were as follows: C₁=7.6 cm (3.0"), C₂=6.6 cm (2.6"), C₃=7.0 cm (2.75"), C₄=5.1 cm (2.0"), C₅=3.6 cm (1.4"), C₆=0 cm (0.0").</p> <p>The displacement of the left B-pillar resulted in the release of the left door latch from the strike post. In addition, the left wheel contact resulted in a fracture of the right tie rod.</p> <p>Damaged components included the left front wheel, right tie rod, left front fender, left door panel, left sill, left B-pillar, and the left rear quarter panel.</p>

15. & 16. Profiles views of maximum crush at the **left front bumper corner**.

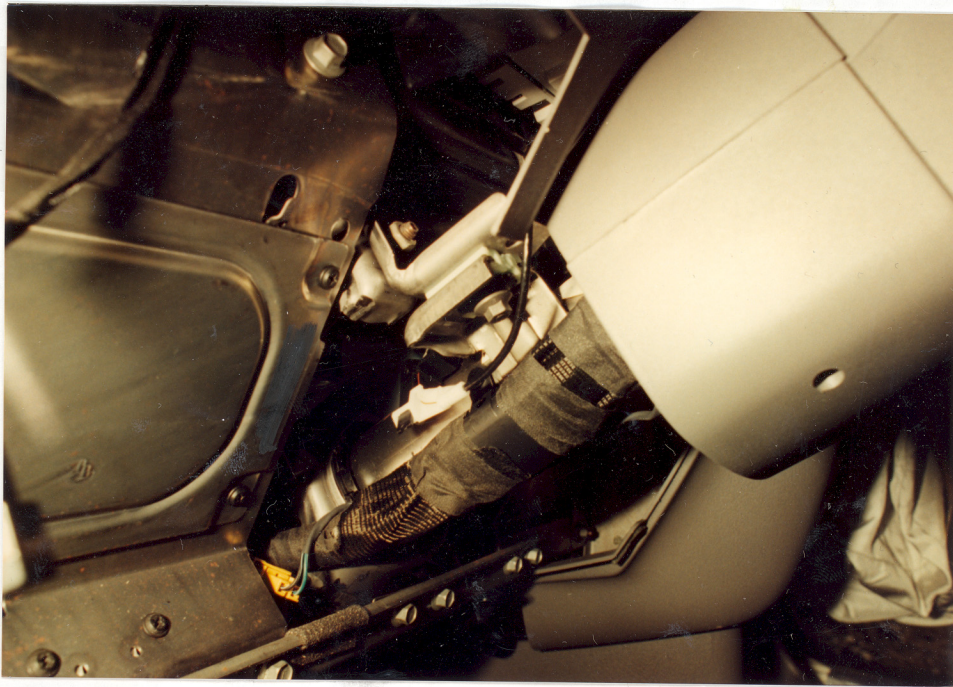
The driver's left knee probably contacted the left side of the plastic knee bolster. There was no evidence of contact to the exterior surface of the bolster, however, upon removal of the bolster to inspect the energy absorbing steering column, the lower left outboard mounting bracket of the bolster was fractured at the screw position. This damage could have resulted from knee loading or during the assembly process of the vehicle.

31. Energy absorbing steering column and left shear capsule (no compression).

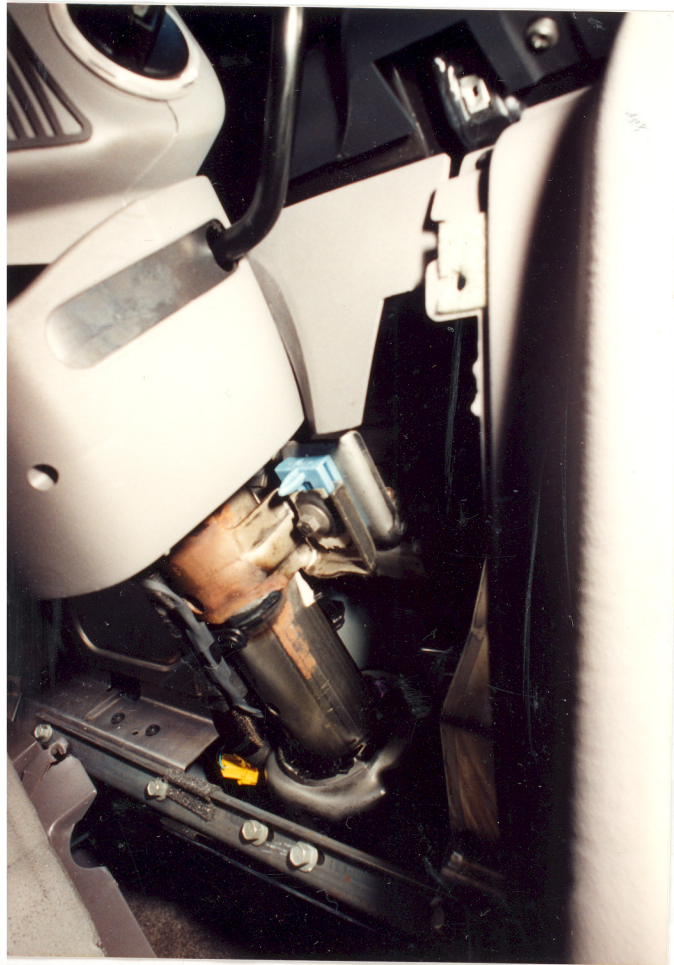
32. Right shear capsule; elongated block, no compression.

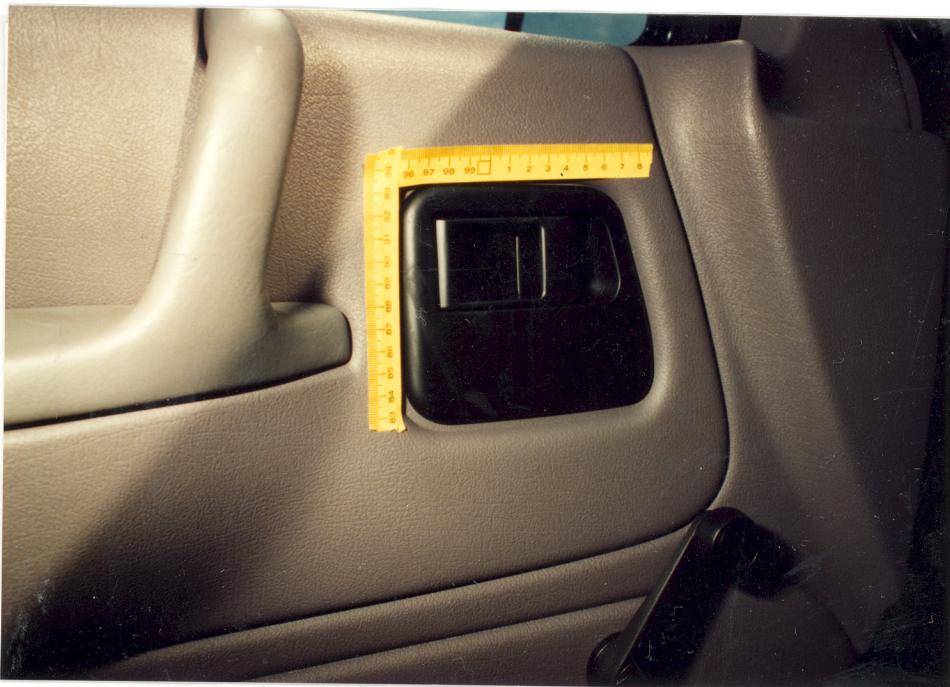
the air bag deployment, however, the inflating air bag contacted the anterior aspects of the driver's forearms which displaced his left hand from the steering wheel rim. The hand/wrist area contacted and scuffed the left door release lever plastic trim panel located at the upper forward quadrant of the door panel. The driver's left knee probably impacted the left side of the plastic knee bolster as he responded to the frontal impact force. Although no direct loading evidence was visible to the exterior surface of the bolster, the lower left mounting bracket was fractured at the head of the attachment screw.

36. Probable driver left hand contact (scuff/smudge/possible tissue) to the door release lever and trim panel.

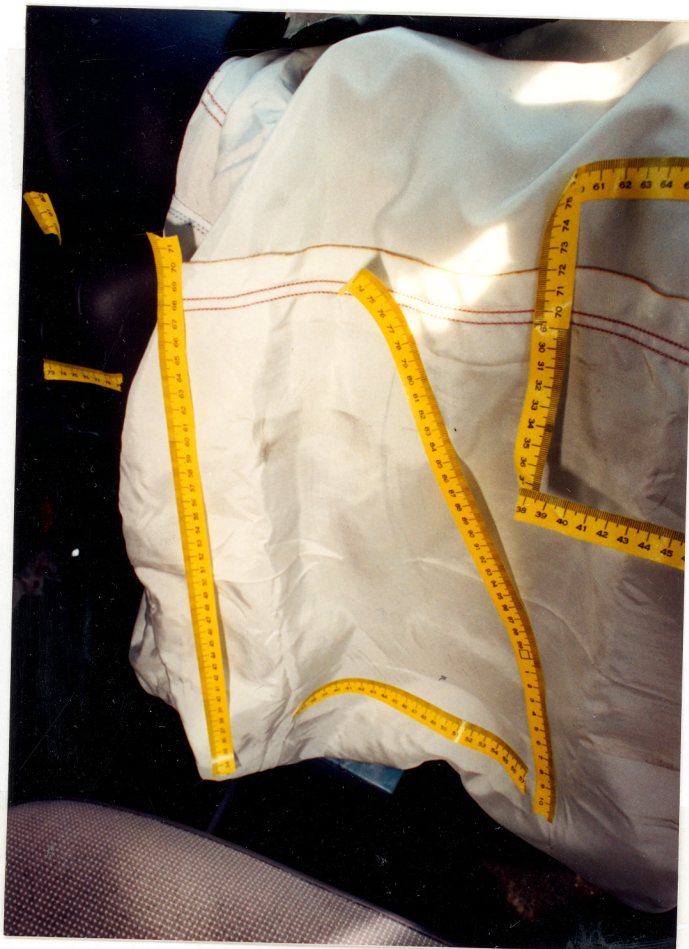
42. Longitudinally orientated gray vinyl transfers on left side of the passenger air bag.

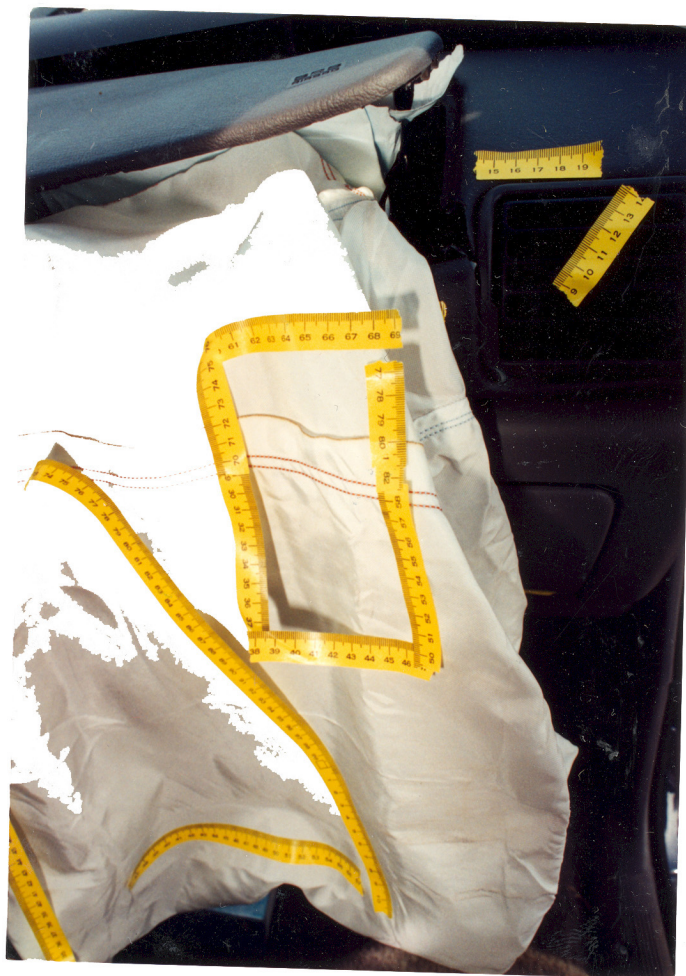
Passenger side air bag deployment against the child occupant's facial and neck areas resulted in numerous areas of tissue transfers. Located at the upper right quadrant of the air bag was an area of scattered tissue fragments which occupied an area of 3.2 x 4.45 cm (1.25 x 1.75"). These transfers are documented in Photograph Nos. 43 and 44. Additional tissue transfers were noted to the upper right side surface of the bag. These areas consisted of heavy transfers embedded into the fabric of the bag. The first tissue transfer to the side of the bag was located 12.7-20.3 cm (5.0-8.0") below a triangular blue stitch line and 7.0-10.8 cm (2.75-4.25") right of the apex of the stitch pattern. The second transfer extended 15.9-21.6 cm (6.25-8.5") right of the blue stitch line apex and continued from the end of the stitch line to a point located 7.6 cm (3.0") below the stitch line (refer to Photograph Nos. 45-48). An additional area of tissue was noted to the lower right quadrant of the windshield. This tissue involved fragments that were expelled from the occupants neck area as the bag expanded against the soft tissue.

43. Tissue transfer on right side area of the passenger side air bag.

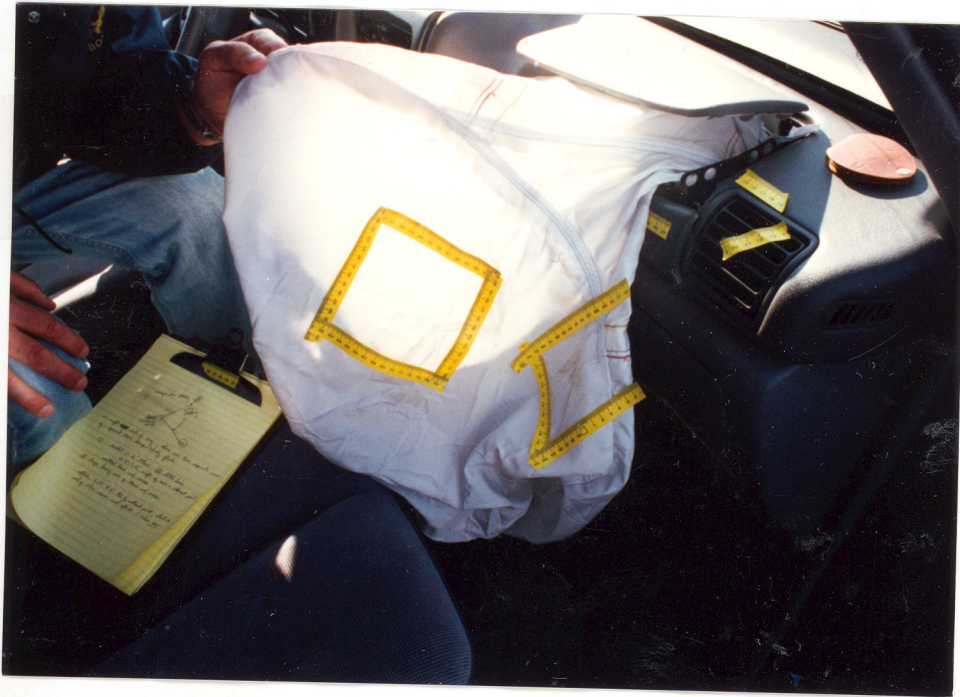
45. Additional tissue transfers on the right side panel of the passenger side air bag.

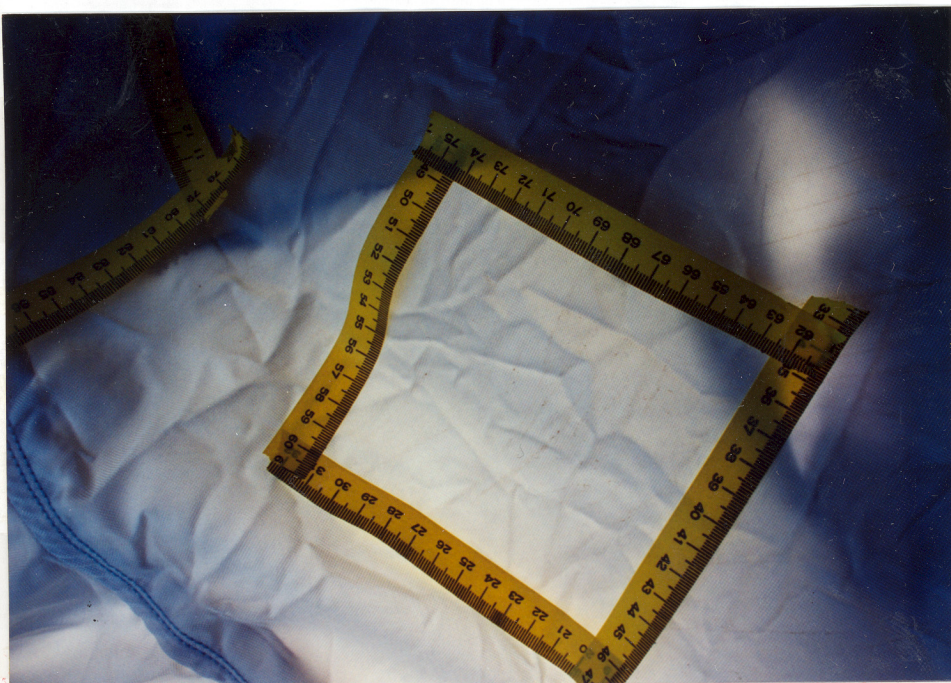
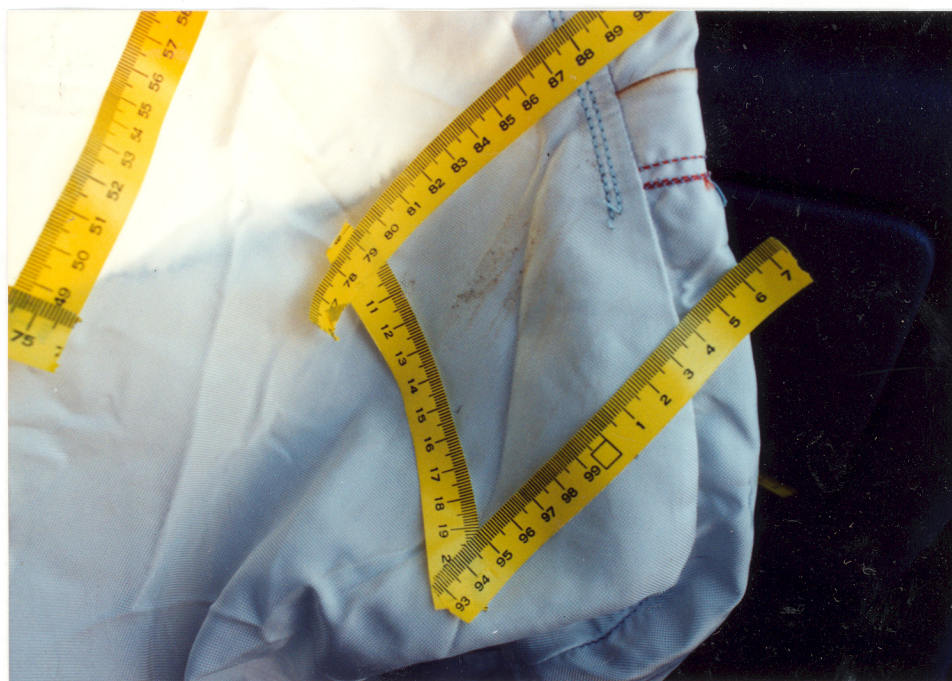
47. & 48. Additional close-up views of the right side tissue transfers.

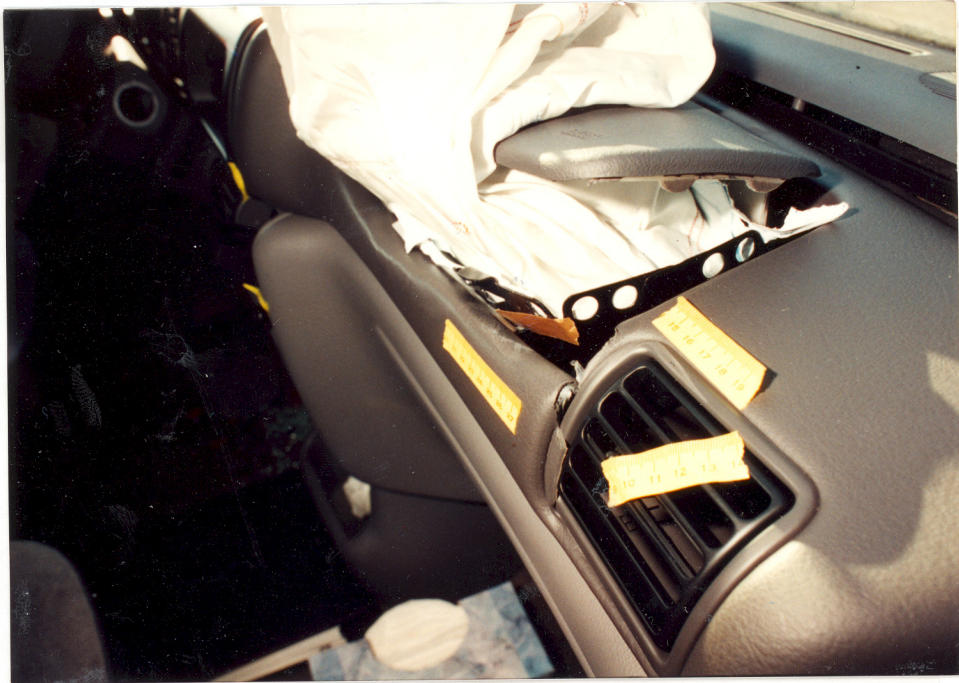
The bag expanded against the stamped steel air bag mounting bracket. The sides of the bracket were bowed outward approximately 3.2 mm (0.125") while the lower flange of the bracket was bowed 2.5 cm (1.0"). The outward bowing of the lower flange deflected the padded mid instrument panel 1.3 cm (0.5") downward at the mid point of the module assembly. An air bag fabric transfer was noted to the deformed padded mid panel (17.5-19.5") left of center and 69.9 cm (27.5") above the floor pan. The bowing of the module assembly, in combination with the opening of the top hinged cover flap and air bag expansion, resulted in a tear of the mid/upper instrument panel juncture at the narrow point adjacent to the right vent louver (refer to Photograph No. 51). A patterned air bag fabric transfer was noted to the left side of the right vent louver. The transfer measured 3.8 cm (1.5") vertically and 4.4 cm (1.75") horizontally across the upper left corner of the vent assembly.

49. Outward bowing of the lower and side surfaces of the passenger side air bag module mounting flange.

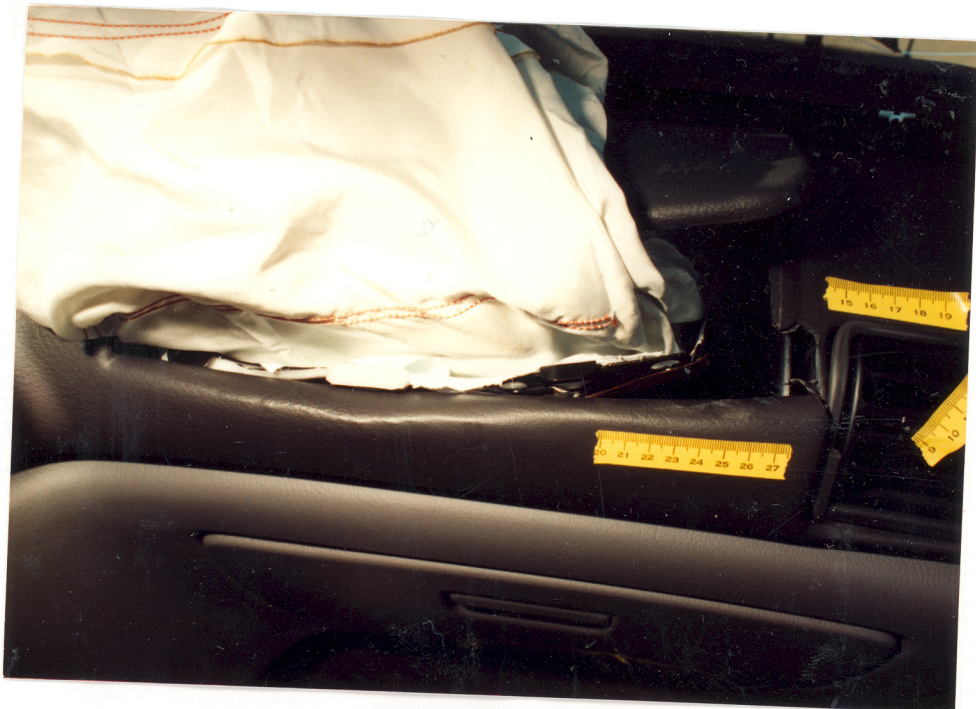
50. Lower flange bowed outward 2.5 cm (1.0") into mid instrument panel.

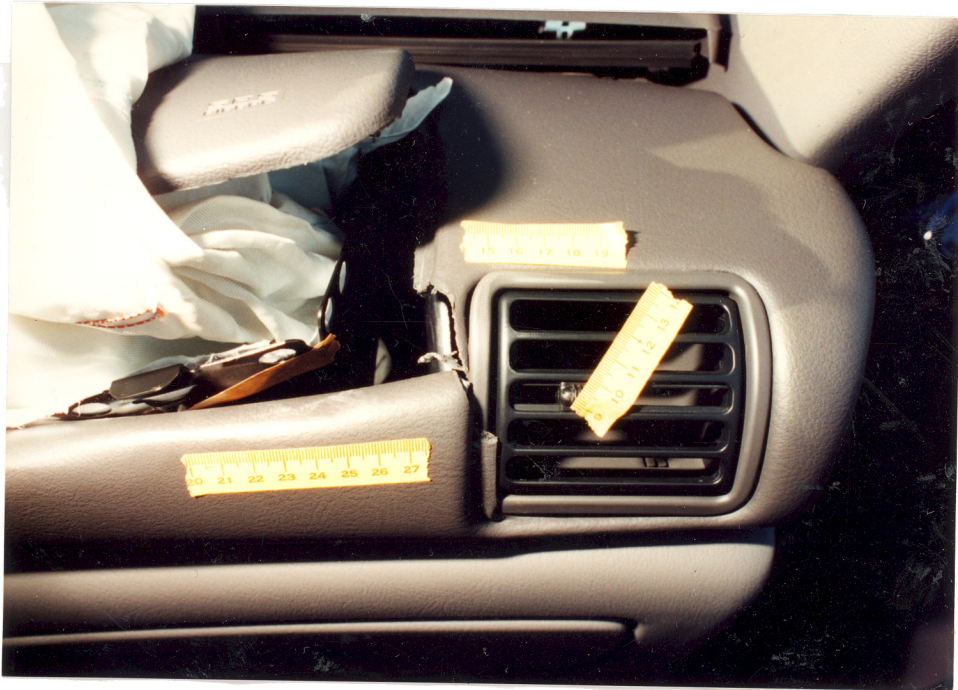
51. Air bag fabric transfers on deformed mid panel and right vent louver.

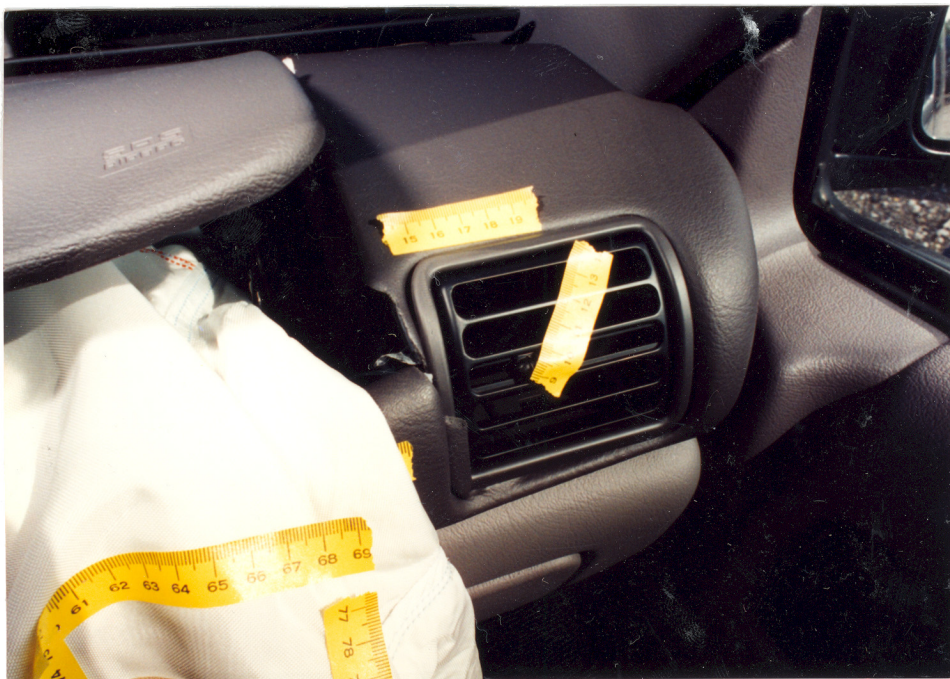
52. Close-up view of the air bag transfers on the right vent louver.

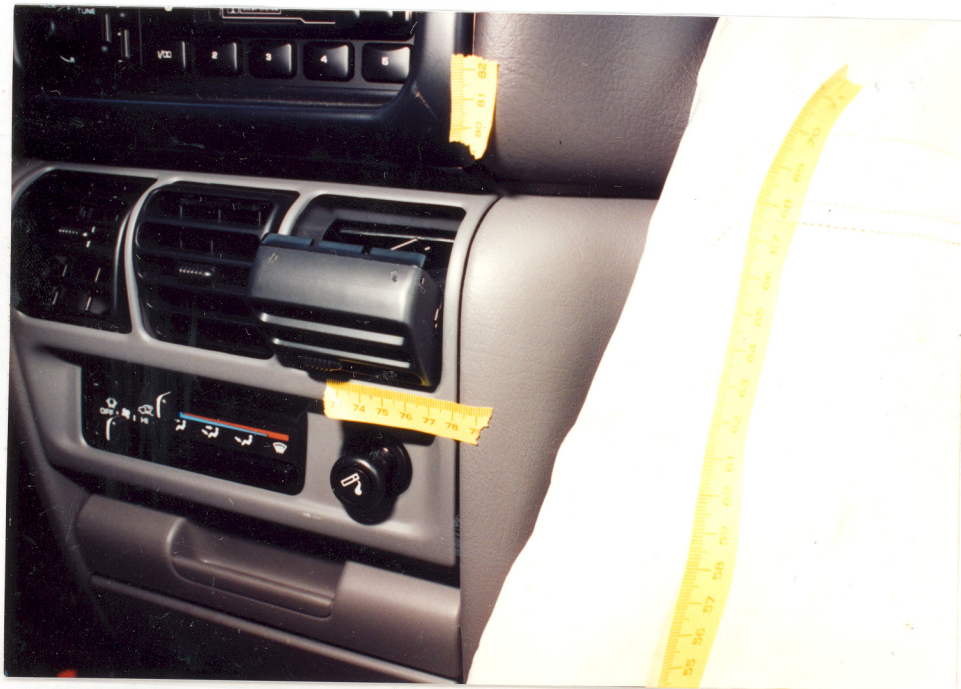
The center mid aspect of the instrument panel contained a series of three vent louvers located between the radio and the ventilation controls. The plastic right vent louver was fractured, but remained within its housing. A scuff mark was noted to the right side of the louver 11.2 cm (4.4") right of center and 21.0-22.2 cm (8.25-8.75") below the upper panel. Located directly above the fractured louver was a tissue transfer with a hair fiber within the transfer. A scuff mark surrounded the transfer which was 10.2 cm (4.0") right of center and 13.0 cm (5.1") below the upper panel. This transfer probably resulted from a hand contact and was within the area of the radio, however, there was no reported hand injuries to either the driver or the child right front passenger.

54. Fracture of the right mid mounted vent louver with tissue transfer located above.

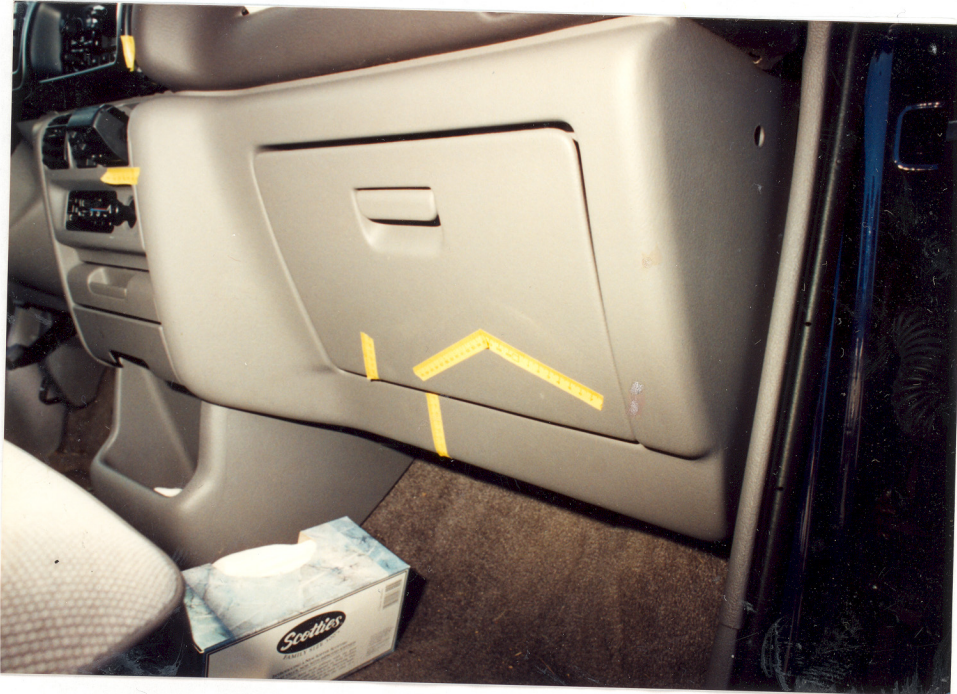
5. Possible foot scuff marks from the right front passenger on the glove box door.

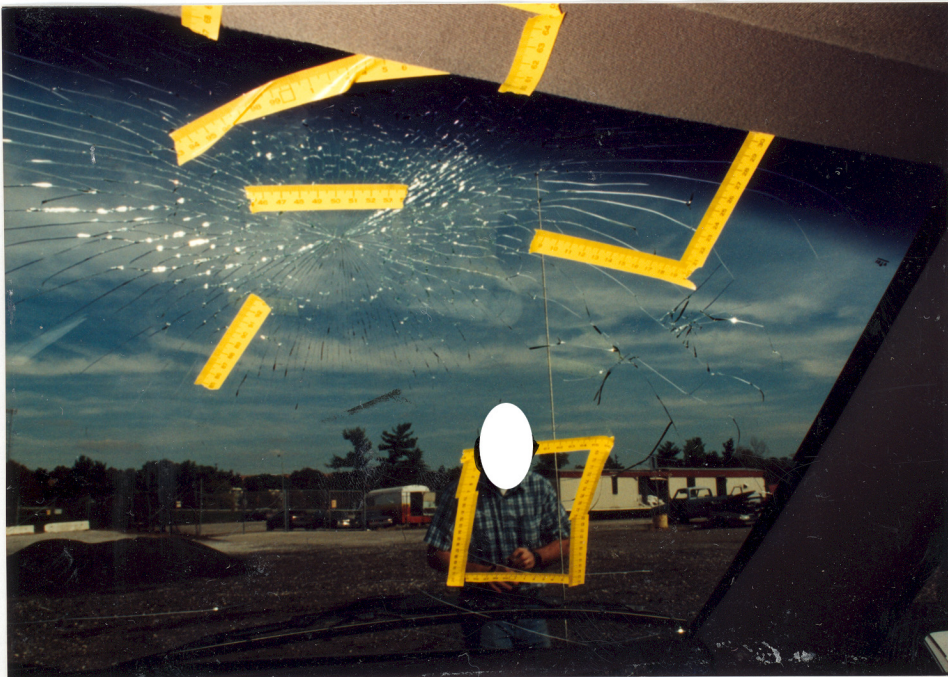
In addition to the fabric transfers on the windshield, a star-like crack occurred to the laminated glazing, located 27.9 cm (11.0") right of center and 6.4 cm (2.5") below the header. There was no contact evidence surrounding the impact point to the windshield, therefore the source of the crack was unknown. The possible sources include occupant contact; either head or hand contact from the right front passenger, or a fracture that resulted from air bag contact.

56. Crack and air bag contact to the laminated windshield.

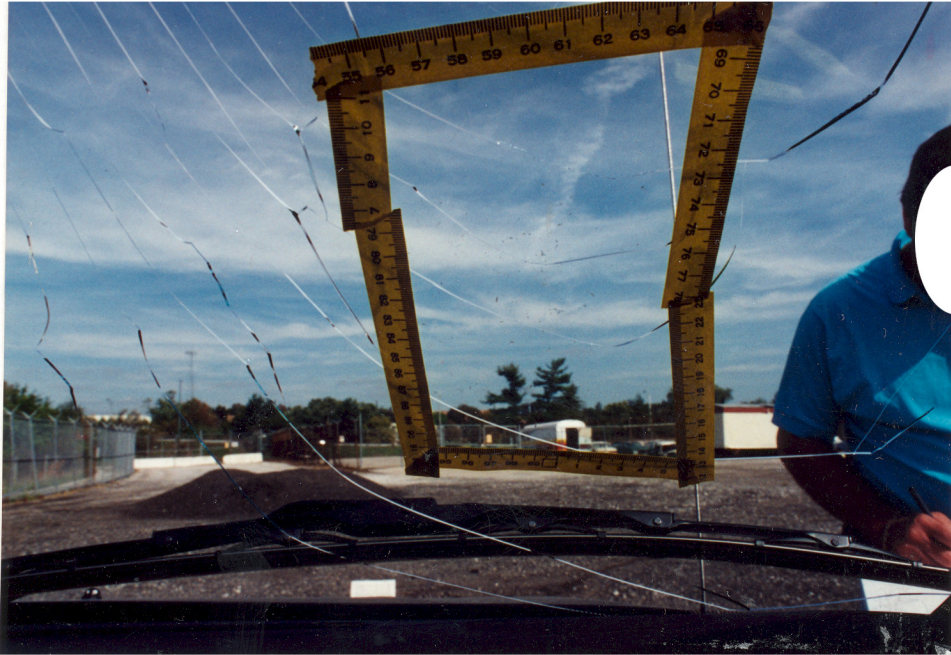
57. Probable tissue transfer on the lower right quadrant of the windshield.

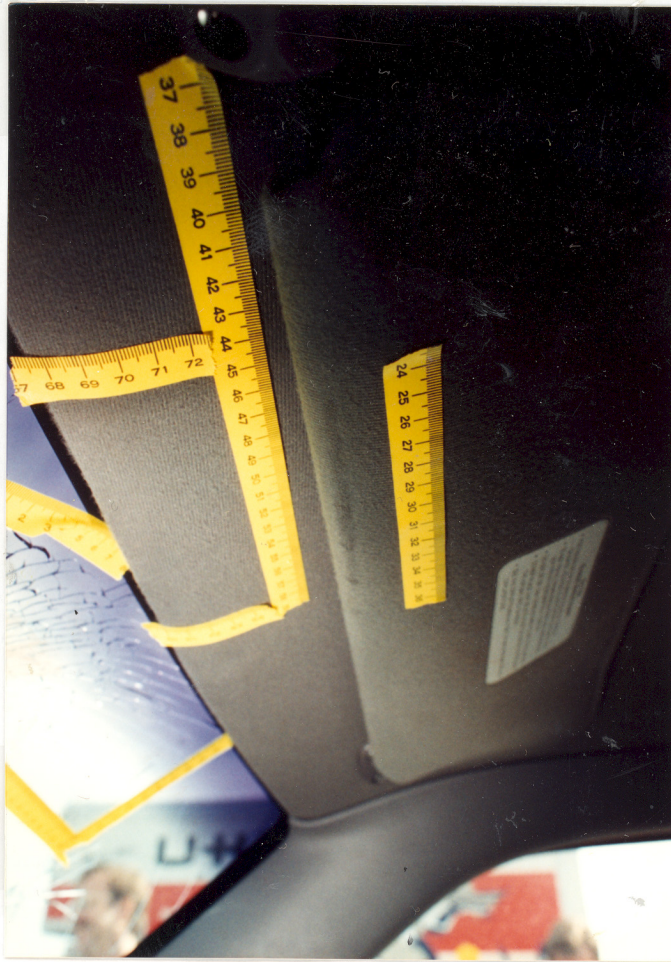
59. Abraded sunvisor and headliner from air bag contact.

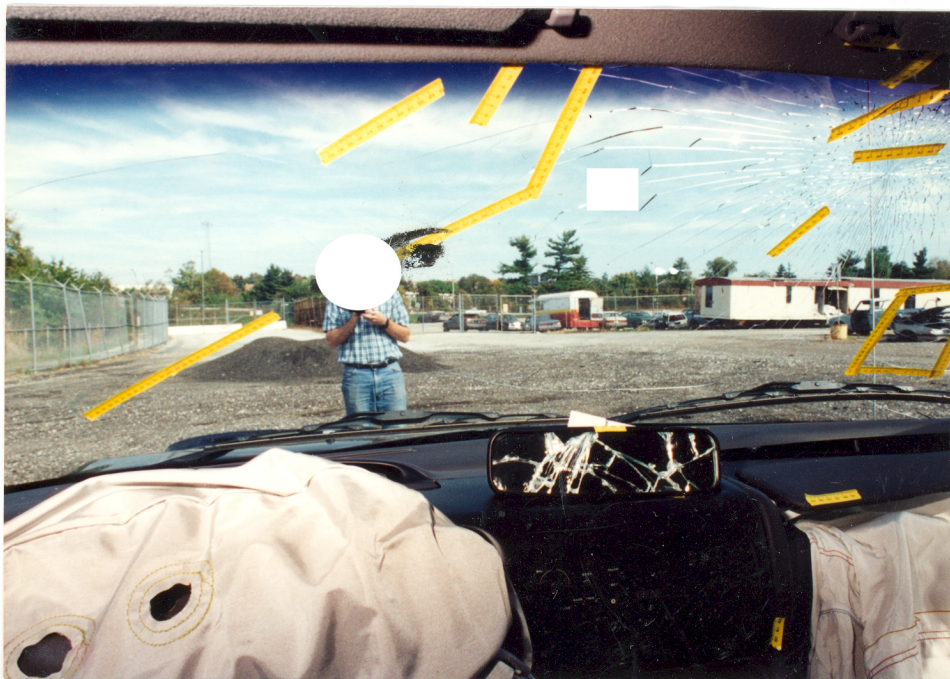
The left side area of the expanding passenger side air bag contacted the interior mounted rear view mirror as the right front occupant altered the deployment trajectory of the bag. The bag contact produced a fabric transfer to the right side of the mirror and displaced the mirror to the left, separating it from the windshield mount. Although no damage occurred to the plastic frame of the mirror, the contact cracked the full width of the mirror glass. The separated mirror was displaced across the left side of the windshield before coming to rest on the upper instrument panel at the base of the left A-pillar.

60. Fractured and separated rear view mirror from air bag contact.

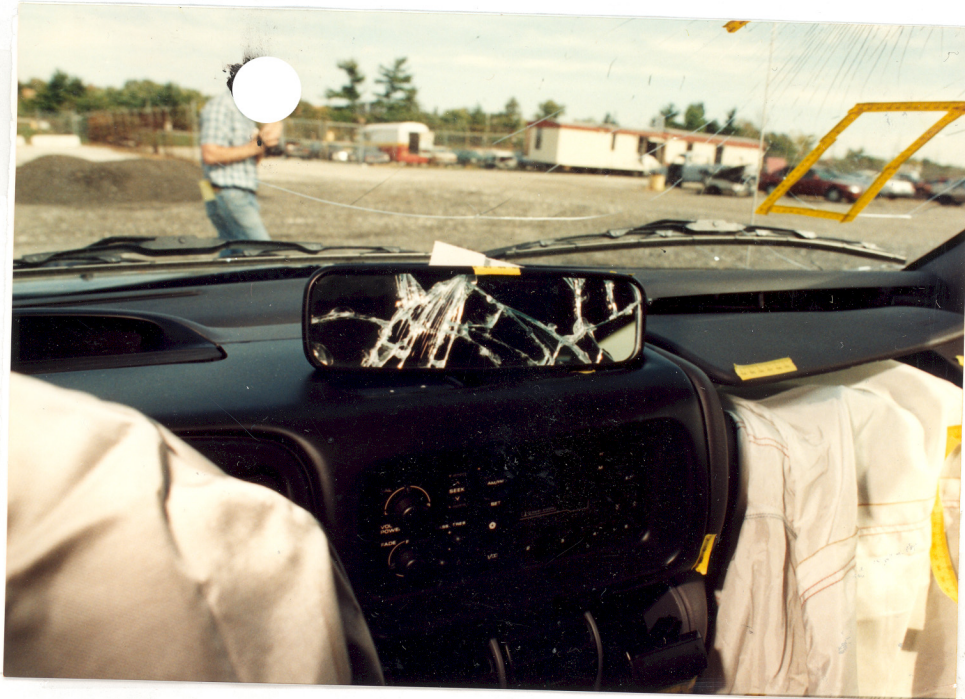
61. Close-up view of the cracked mirror.

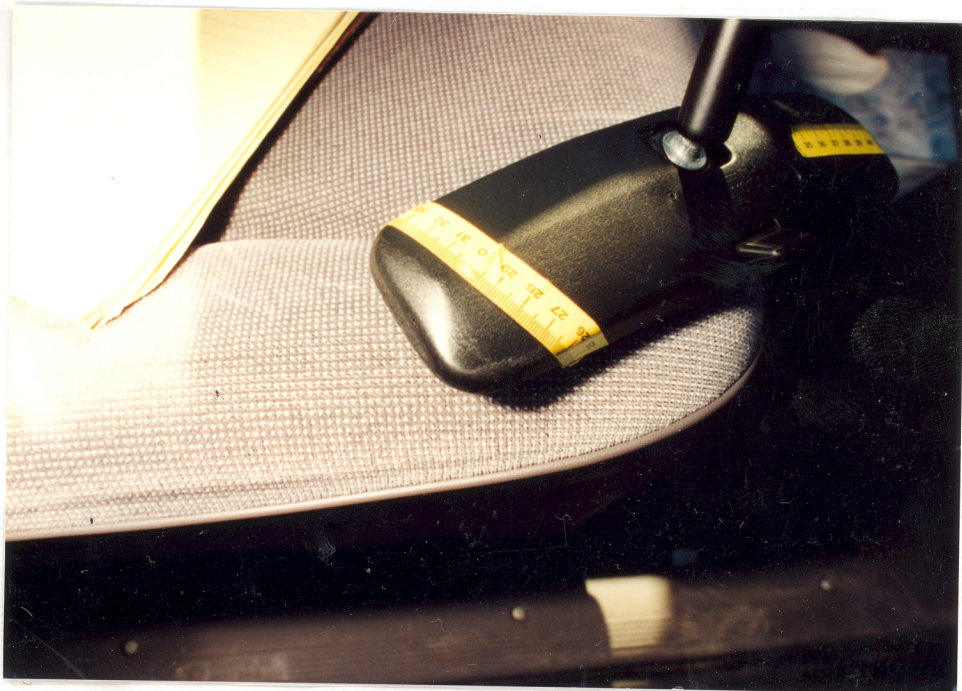
62. Air bag fabric transfer to the right side of the rear view mirror.

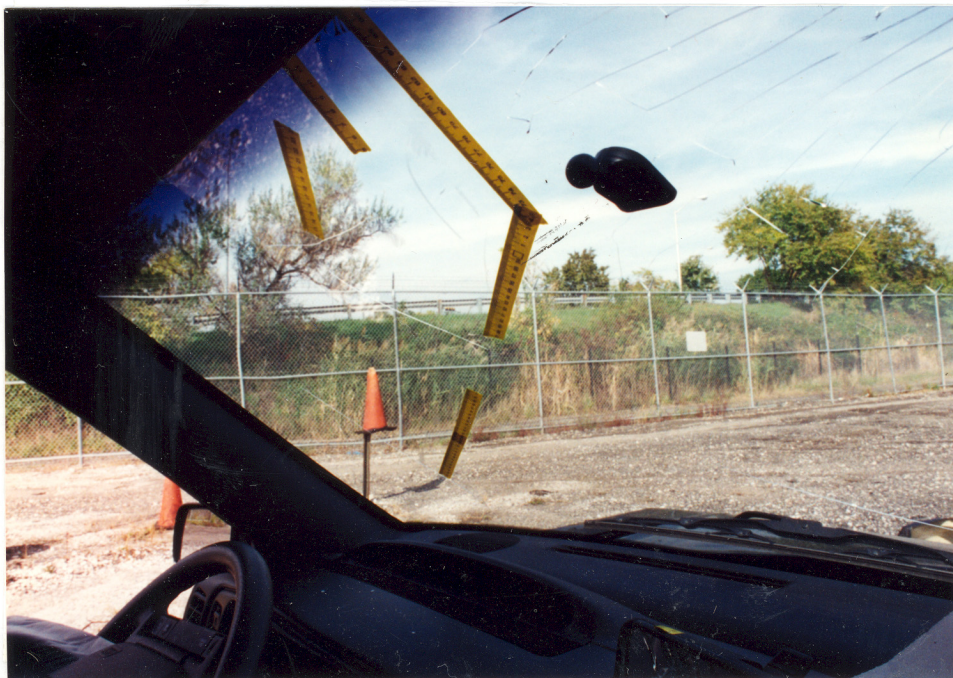
64. Mirror scuff across the left side of the windshield.

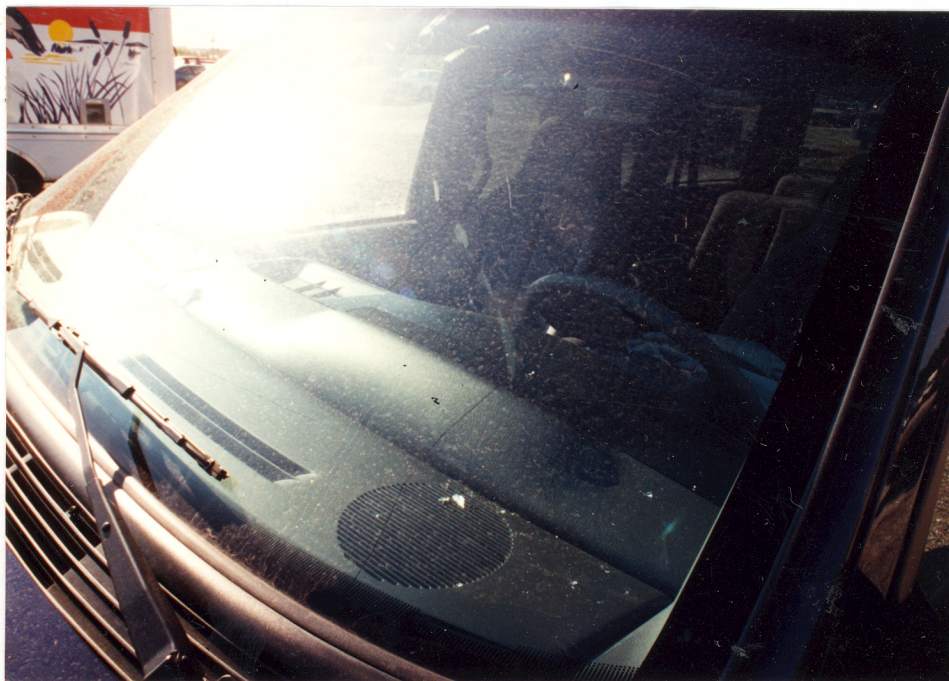
65. Exterior view of the mirror scuff across the left side of the windshield.

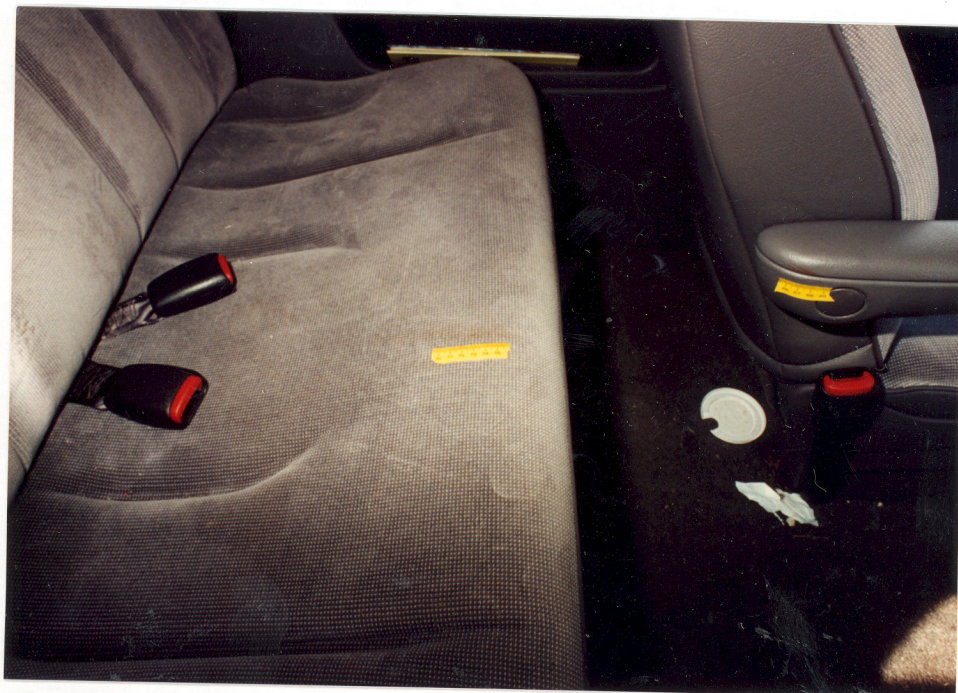
The child occupant was displaced rearward and came to rest lying across the interior of the vehicle with her head resting on the inboard armrest of the driver's seat. Her pelvis and lower extremities remained on the right front seat cushion with the lap belt positioned around her waist. Her final rest position was confirmed by a blood transfer noted to the armrest and from statements of the rear seated occupants.

67. Blood transfer of the right (inboard) armrest of the driver's seat.

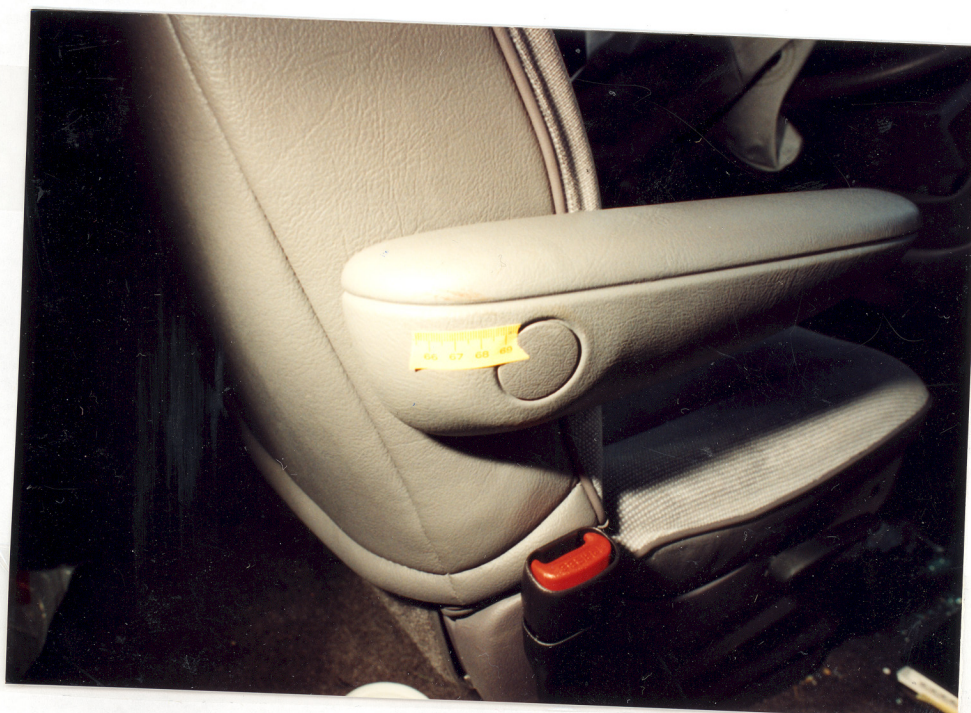
68. Close-up view of the blood transfer from final rest of the right front passenger's head/neck.

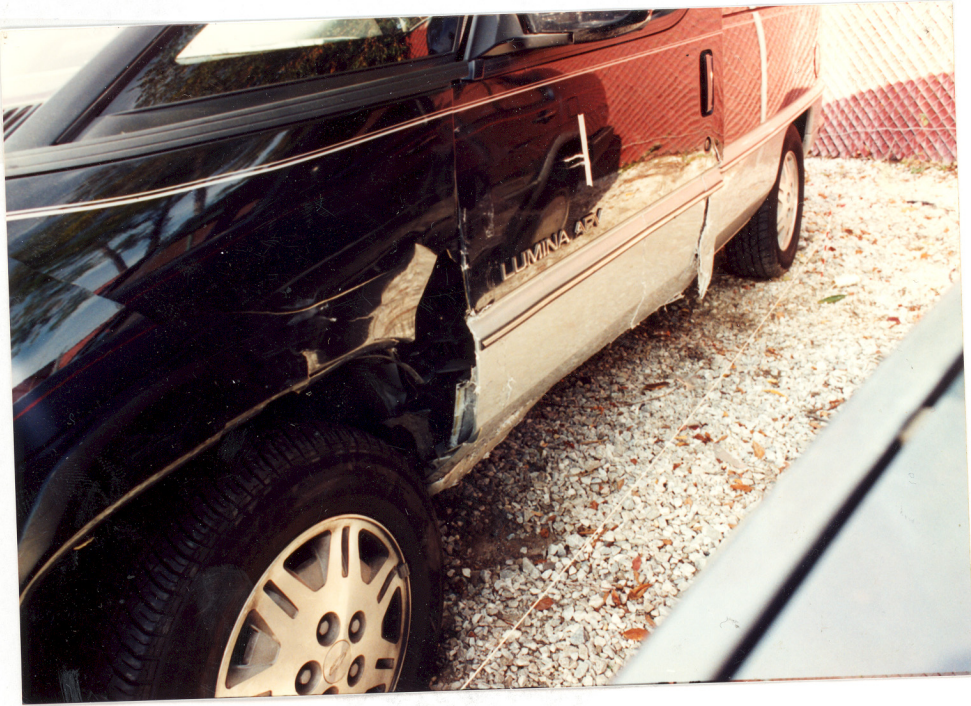
76. Direct contact damage on the left side area of the Lumina APV.

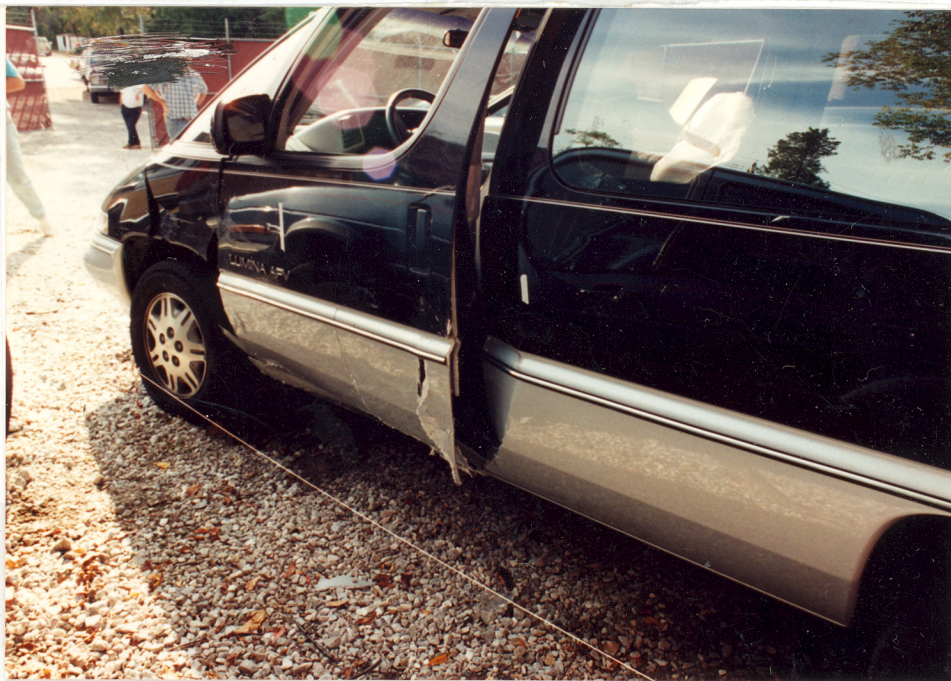
78. Close-up view of the direct contact damage.
